Manhole Inspection Summary

Manhole # S53G__010MH

Location Address: **behind 272 Highland St - Clinton-Highland Alley**

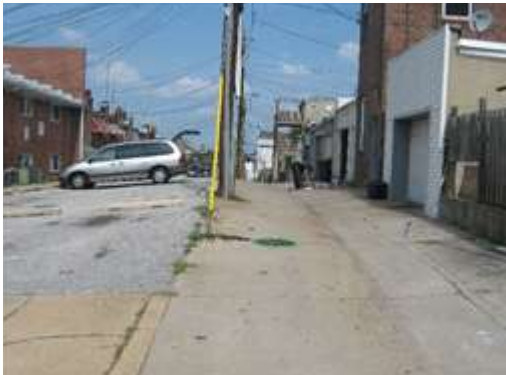
Location View

Facing north

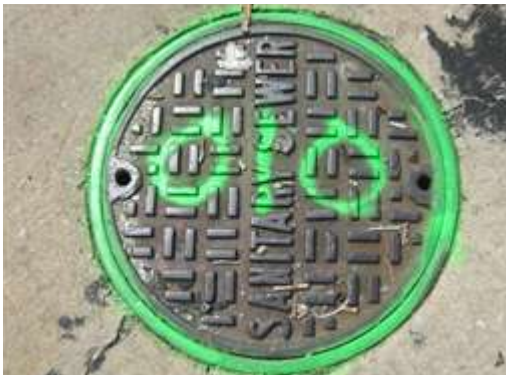
Miscellaneous

MH Lid

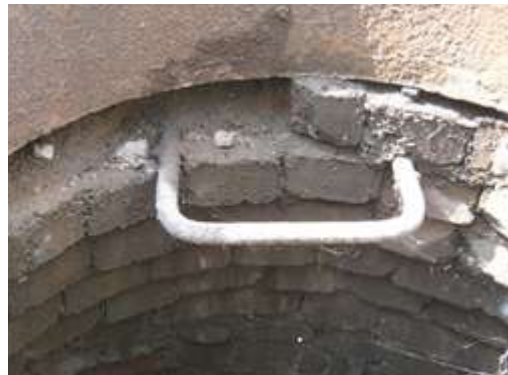
Defect 3

Condition: ☐ Sound ☐ Cracked ☐ Root Intrusion ☐ Loose Brick ☒ **Deteriorated**

Infiltration: ☐ None ☒ **Joint** ☐ Cracks ☐ Mortar ☐ Roots ☐ Wall

deteriorated chimney with infiltration

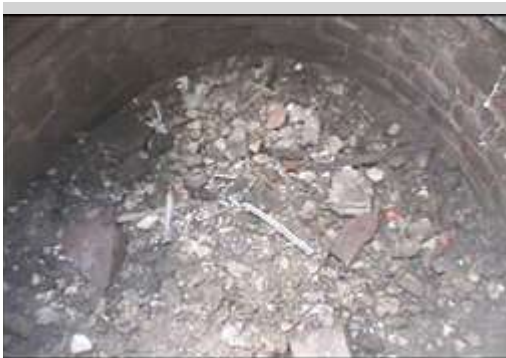
Defect 2

Condition: ☐ Sound ☐ Cracked ☐ Root Intrusion ☐ Deteriorated ☐ Leaks ☒ **Debris**

heavy debris at the base

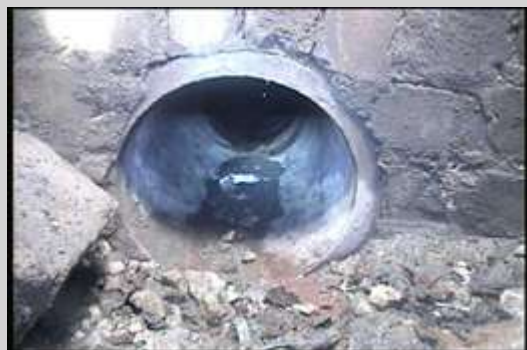
12 O'Clock Outflow

8 in. Circular Gravity Sewer
Pipe Out @ 12 O'Clock
